## ***Building Repairs Report***

**Sefton Road, Crewe, WA11 9QD**

This report provides a record of the Building Repairs Report at: **Sefton Road, Crewe, WA11 9QD** for **Housing Association**. It was surveyed by **Another Surveyor** of **Your Company Name** on the **5th October 2017**. The purpose of the inspection is to assess the internal and external condition of the building, capturing life cycle replacement costs

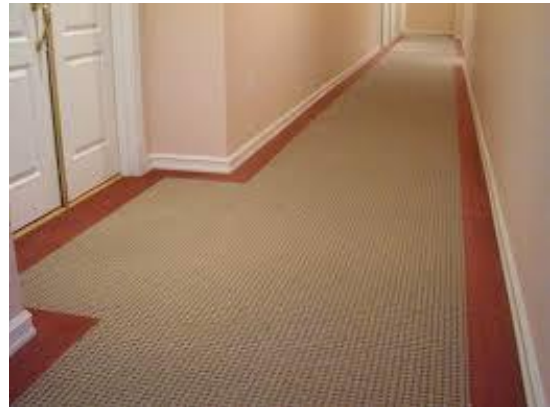
[Photo 2](#)

<b>Flooring</b>		<i>First Floor &gt; Bathroom</i>		<b>8.3</b>
Vinyl Or Linoleum				
<b>Defects</b>			<p><a href="#">(Photo 2)</a></p>

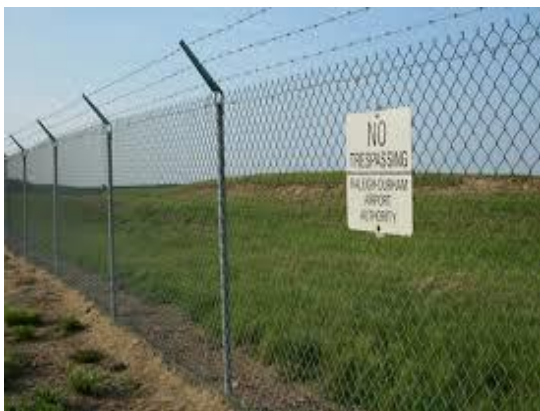
[Photo 3](#)

<b>Boundaries</b>		<i>Front Curtilage</i>		<b>8.4</b>
Timber Fence & Posts				
<b>Defects</b>			<p><a href="#">(Photo 3)</a></p>

Stone Wall			
<b>Defects</b>		<a href="#">(Photo 3)</a>
