Dilapidations Report

23 New Road, Stoke, CH5 3EF

3rd August 2018 by Surveyor 1

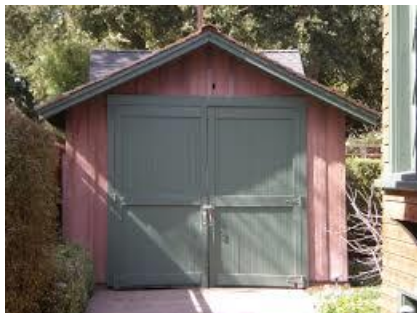
[Photo 1](#)

Element	Description	Condition	Remedial Work	Priority	Photo
Garage 2 Im <i>Front</i>	Integral <i>Here are some supplementary comments about the item.</i>	Poor - Defective garage door	£516 - Renew garage door and frame - Repair garage door	Urgent	(Photo 1)

Garage 2 Im <i>Front</i>		Poor	7.1
Integral			
Defects - Defective garage door	Urgent Remedial Work - Renew garage door and frame - Repair garage door Budget Cost - £516	(Photo 1)

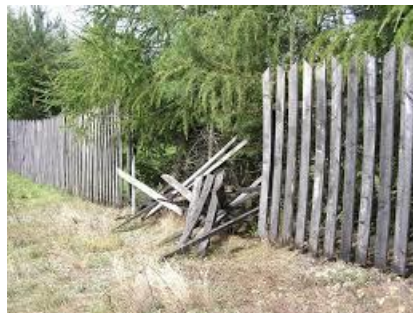
[Photo 2](#)

Fencing 7 Im <i>Ground Floor > Disabled Toilet</i>	Timber Fence 12m High <i>Here are some supplementary comments about the item.</i>	Fair - Defective closeboard panels	£1,162 - Renew chain link fence - Renew paddock gate - Renew fence - Renew car park padlock	Urgent	(Photo 2)

Here are some supplementary comments about the item.			
Fencing 7 Im <i>Ground Floor > Disabled Toilet</i>		Fair	7.2
Timber Fence 12m High			
Defects - Defective closeboard panels	Urgent Remedial Work - Renew chain link fence - Renew paddock gate - Renew fence - Renew car park padlock Budget Cost - £1,162	(Photo 2)

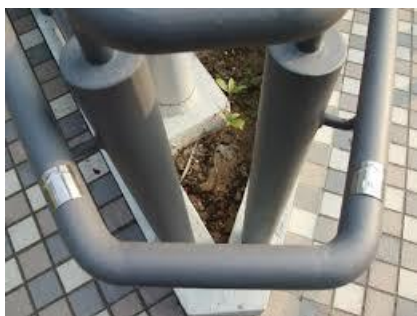
[Photo 3](#)

Here are some supplementary comments about the item.			
Handrails 1 item <i>Front</i>		Poor	7.3
Wooden			
Defects - No handrails provided	Desirable Remedial Work - Fix tapping rail to handrail - Provide handrails both sides Budget Cost - £900	(Photo 3)

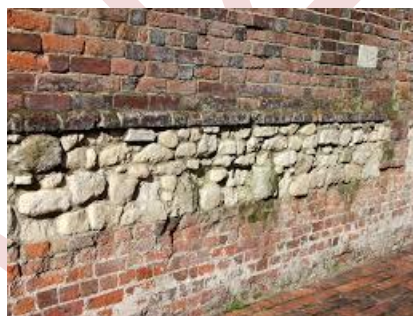
[Photo 4](#)

External Walls 2 no <i>Front</i>	Flemish bond London brick masonry walls to main walls with soldier course above window headers <i>Here are some supplementary comments about the item.</i>	Poor - Poor pointing to brickwork - Dampness problems to the internal faces of external walls	£227 - Renew/form bellcast drip - Renew coping stone	Desirable	(Photo 4)

Here are some supplementary comments about the item.			
External Walls 2 no <i>Front</i>		Poor	7.4
Flemish bond London brick masonry walls to main walls with soldier course above window headers

Defects - Poor pointing to brickwork - Dampness problems to the internal faces of external walls	Desirable Remedial Work - Renew/form bellcast drip - Renew coping stone Budget Cost - £227	(Photo 4)
