Dilapidations Report – SAMPLE ONLY

New Chapel, Sample Town, WC1 5GT

The Old Shoppe
New Chapel
Sample Town
WC1 5GT

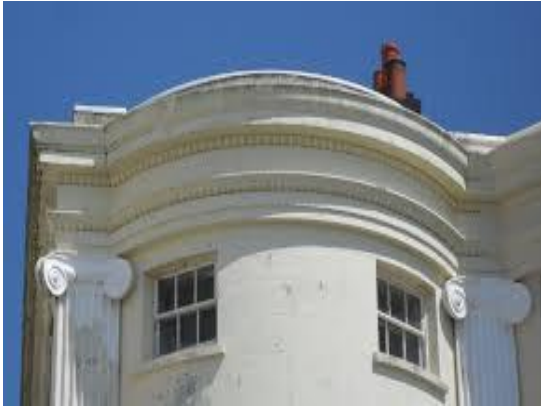
[Fig 1](#)

Element	Description	Condition	Cost	Priority	Photo
External Decoration <i>Ground Floor</i>	Hardwood shop front and windows	Good	£65		(Fig 1)

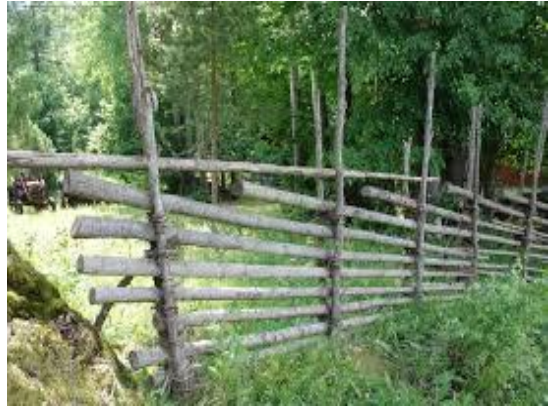
[Fig 2](#)

Boundaries <i>Whole Building</i>	Fence	Fair Damaged	£170	Essential	(Fig 2)

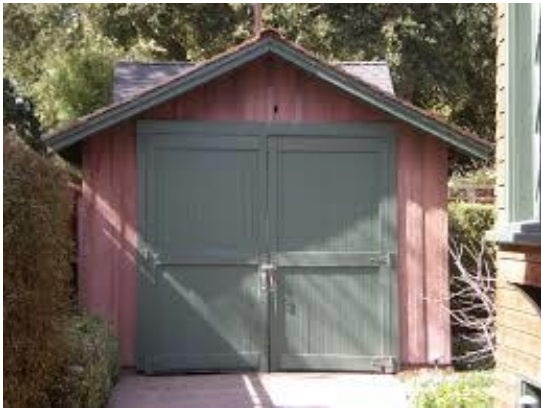
[Fig 3](#)

Garage	Detached	Poor Damaged	£345	Urgent Not an accurate picture	(Fig 3)

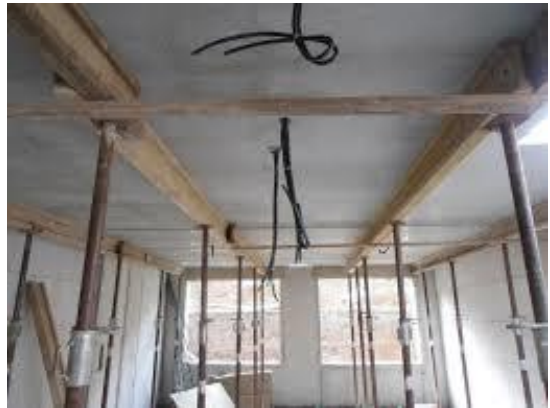
[Fig 4](#)

Element	Description	Condition	Cost	Priority	Photo
Ceilings <i>Under stairs storage area</i>	Concrete	Fair Requires Redecoration	£500	Long Term	(Fig 4)

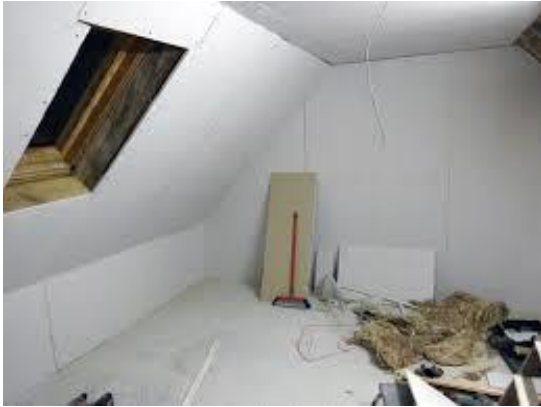
[Fig 5](#)

Ceilings <i>Stairwell</i>	Artex	Poor Cracking to joints in plasterboard ceilings	£123	Desirable Make good where old light fitting removed	(Fig 5)

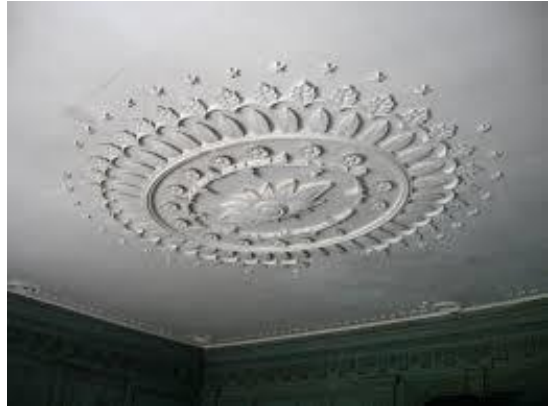
[Fig 6](#)

Ceilings <i>Stockroom</i>	Plaster	Fair Requires Redecoration	£43	Desirable Minor decorations	(Fig 6)

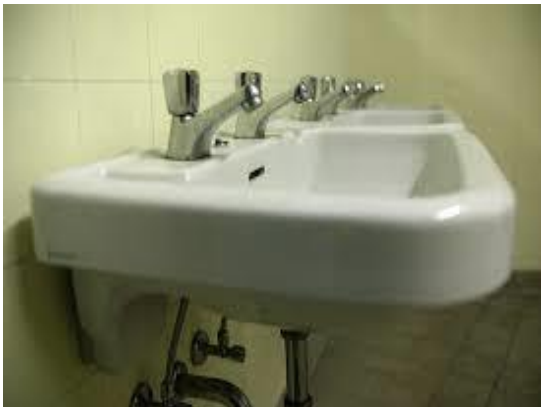
[Fig 7](#)

Sinks <i>WC</i>	Porcelain whb	Fair Damaged; Water staining	£58	Long Term	(Fig 7)

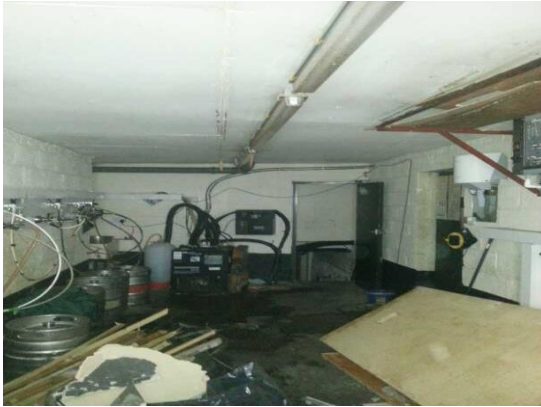
[Fig 10](#)

Lights <i>Lobby</i>	Fluorescent lights	Fair Cracking	£453	Urgent Wattage too low	(Fig 10)
