## ***Fire Door Inspection Report***

***For Eon Housing***

**25 Luton Square Retail Park, Accrington, WA11 9QD**

**Surveyed: 18th January 2019 by Main Surveyor**

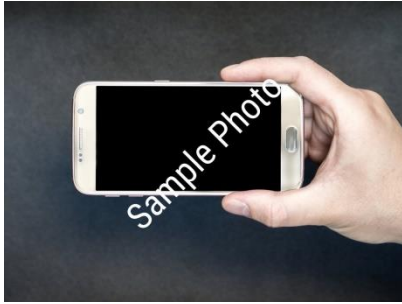
[Photo 1](#)

Fire rated glass to fire door has all beading on both sides.	<b>Non Compliant</b> <i>Here are some supplementary comments about the item.</i>	* Repair beading to glass to ensure a secure fit. <i>Desirable</i>	<a href="#">(Photo 1)</a>

Door closes into keep within 25 seconds.	<b>Compliant</b> <i>Here are some supplementary comments about the item.</i>	No action required	<a href="#">(Photo 1)</a>

Door should fit within frame with gap between 3-5mm.	<b>Compliant</b> <i>Here are some supplementary comments about the item.</i>	No action required	<a href="#">(Photo 1)</a>

Fire rated glass to fire door has all beading on both sides. <i>Ground Floor &gt; Foyer</i>	* Repair beading to glass to ensure a secure fit.	D001	Non Compliant Desirable	<a href="#">(Photo 1)</a>

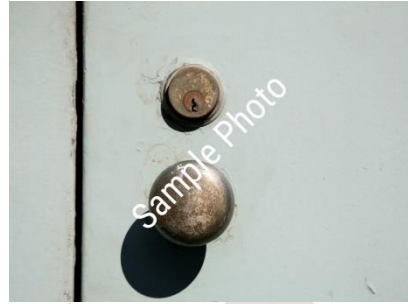
[Photo 2](#)

<b>Basement</b>	<a href="#">(Photo 2)</a>	
No access <i>Here are some supplementary comments about the item.</i>

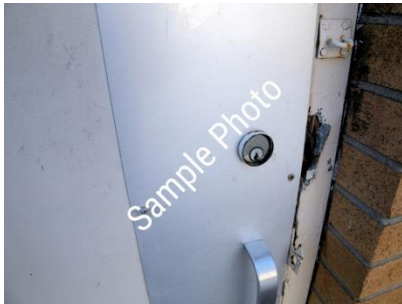
[Photo 3](#)

Item	Response	Recommended Actions	Photo
Fire door physically un-damaged.	<b>Non Compliant</b> <i>Here are some supplementary comments about the item.</i>	* Arrange for fire door repairs. <i>Essential</i>	<a href="#">(Photo 3)</a>

Item	Response	Recommended Actions	Photo
Fire door physically un-damaged.	<p><b>Non Compliant</b></p> <p><i>Here are some supplementary comments about the item.</i></p>	<p>* Arrange for fire door replacement.</p> <p><b>Urgent</b></p>	<p><a href="#">(Photo 3)</a></p>

Item	Actions	Ref	Compliance	Photo
Fire door physically un-damaged. <i>Ground Floor &gt; Foyer</i>	* Arrange for fire door repairs.	D001	Non Compliant Essential	<a href="#">(Photo 3)</a>

Fire door physically un-damaged. <i>First Floor &gt; R101</i>	* Arrange for fire door replacement.	D002	Non Compliant Urgent	<a href="#">(Photo 3)</a>

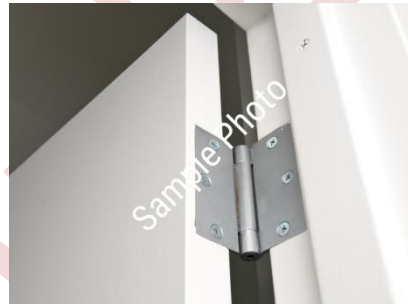
[Photo 4](#)

Sufficient and adequate hinges.	<b>Non Compliant</b> <i>Here are some supplementary comments about the item.</i>	* Add intumescent packers behind hinges. <i>Essential</i>	<a href="#">(Photo 4)</a>

Sufficient and adequate hinges. <i>Ground Floor &gt; Foyer</i>	* Add intumescent packers behind hinges.	D001	Non Compliant Essential	<a href="#">(Photo 4)</a>

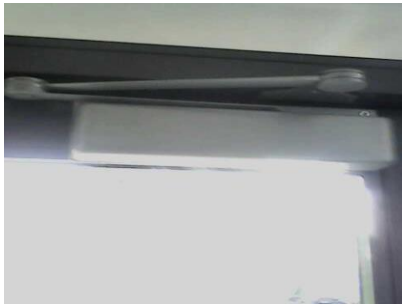
[Photo 5](#)

Door closer fitted and working.	<b>Non Compliant</b> <i>Here are some supplementary comments about the item.</i>	* Replace with a certified closer. <i>Essential</i>	<a href="#">(Photo 5)</a>

Door closer fitted and working.	* Replace with a certified closer.	D001	Non Compliant Essential	<a href="#">(Photo 5)</a>

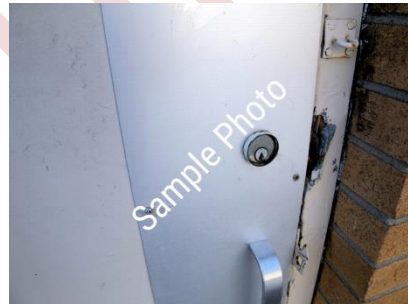
[Photo 6](#)

Frame to fire door secure.	<b>Compliant</b> <i>Here are some supplementary comments about the item.</i>	No action required	<a href="#">(Photo 6)</a>

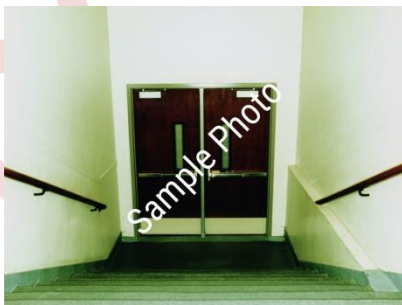
[Photo 7](#)

Door closes without grounding on floor.	<b>Compliant</b> <i>Here are some supplementary comments about the item.</i>	No action required	<a href="#">(Photo 7)</a>

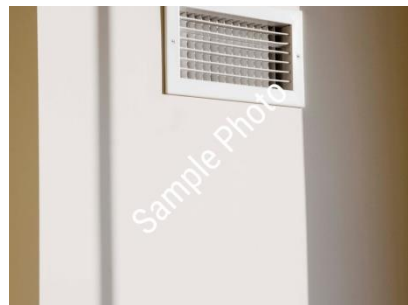
[Photo 8](#)

Fire resisting doors should be free of air vents.	<b>Compliant</b> <i>Here are some supplementary comments about the item.</i>	No action required	<a href="#">(Photo 8)</a>

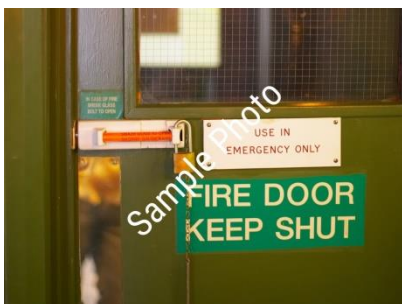
[Photo 9](#)

Correct signs should be fitted on all but bedroom doors.	<b>Compliant</b> <i>Here are some supplementary comments about the item.</i>	No action required	<a href="#">(Photo 9)</a>

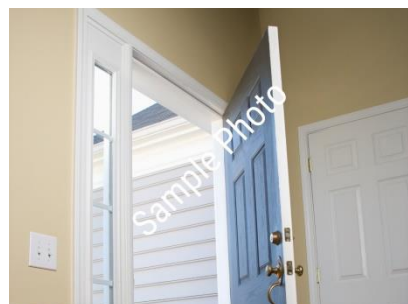
[Photo 10](#)

Intumescent seals fitted correctly to door or frame.	<b>Compliant</b> <i>Here are some supplementary comments about the item.</i>	No action required	<a href="#">(Photo 10)</a>
