HHSRS Report

For James Holroyd of Eon Housing

27 Baker Street, Chester, CW9 4QT

Surveyed: 8th February 2019 by Main Surveyor

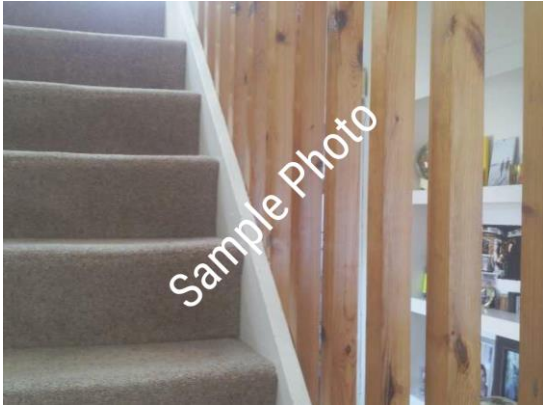
[Photo 7](#)

Falls associated with Stairs and Steps	Category	Action	Band	Score	Photo
(All persons 60 or more years of age) <i>Kitchen; Stairs</i> *Tread lengths - of less than 280mm or greater than 360mm. *Riser heights - of less than 100mm or greater than 180mm. *Openings - in stairs or guarding through which a 100mm diameter sphere can pass. *Lack of handrails - the absence to both sides of the staircase. *Height of handrails - set below 900mm or above 1,000mm.	Risk Identified Category 1 Here are some supplementary comments about the item.	Mandatory	B	2462.34

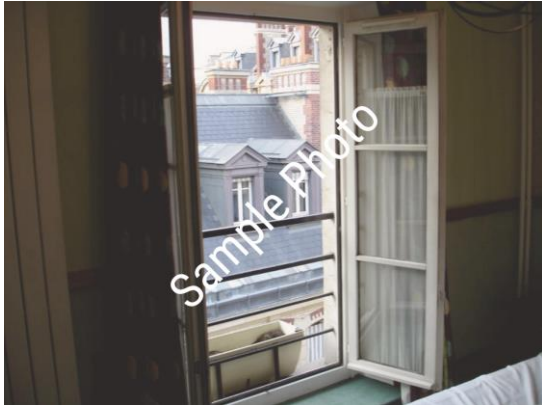
[Photo 8](#)

Falls between Levels	Category	Action	Band	Score	Photo
(Under 5 years) <i>Lounge; Bedroom 1; Bedroom 2</i> *Sill heights - less than 1,100mm above floor level and/or lack of safety glass or guarding. *Non-safety glass - the lack of safety glass where appropriate in the window or guarding.	Risk Identified Category 1 Here are some supplementary comments about the item.	Mandatory	B	2473.59

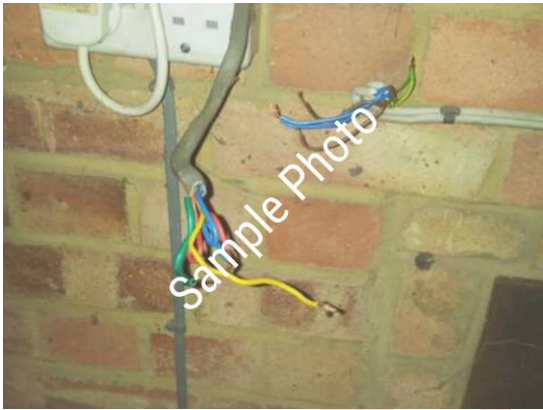
[Photo 9](#)

Electrical Hazards	Category	Action	Band	Score	Photo
(Children under 5 years) <i>Lounge; Bathroom; Shower Room</i> *Disrepair of installation - including to supply, meters, fuses, wiring, sockets, light fittings or switches.	Risk Identified Category 2 Here are some supplementary comments about the item.	Discretionary	D	707.26
