Legionella Risk Assessment

Luton Square Retail Park, Accrington, WA11 9QD

3rd October 2017 by Inspector 3

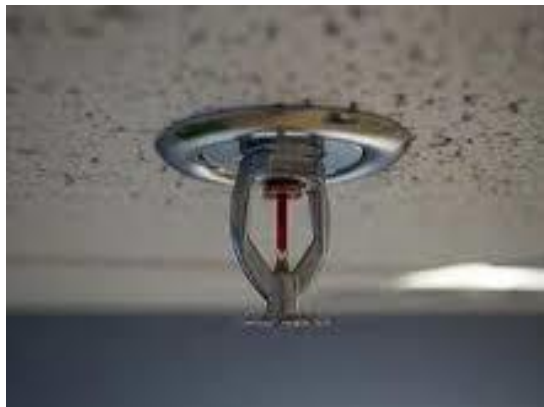
[Photo 1](#)

Sprinklers		<i>Office Areas</i>	Passed	3.9
Any type				
Actions * None	Compliances - None Non Compliances - None		(Photo 1)

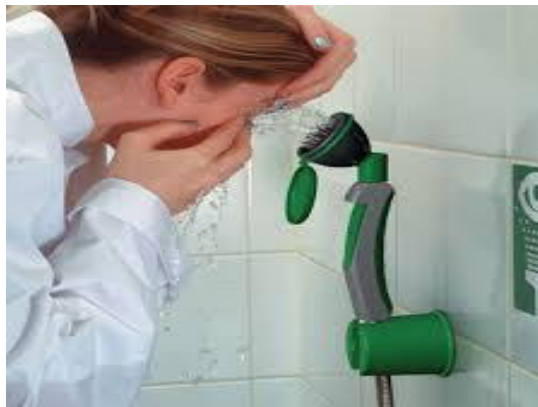
[Photo 2](#)

Eye Wash Sprays		<i>Staff Room</i>	Passed	3.6
Any type				
Actions * None	Compliances - No visible contamination Non Compliances - None		(Photo 2)

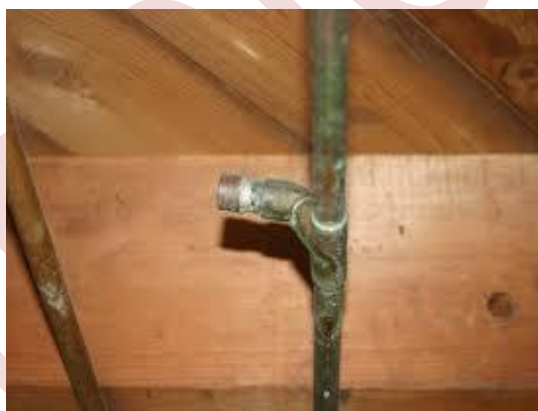
[Photo 4](#)

Deadlegs		<i>Disabled Toilet</i>	Failed	3.4
Any type				
Actions * Remove deadlegs <i>Urgent by 2017-10-12</i>	Compliances - None Non Compliances - Visible contamination - Visible corrosion		(Photo 4)

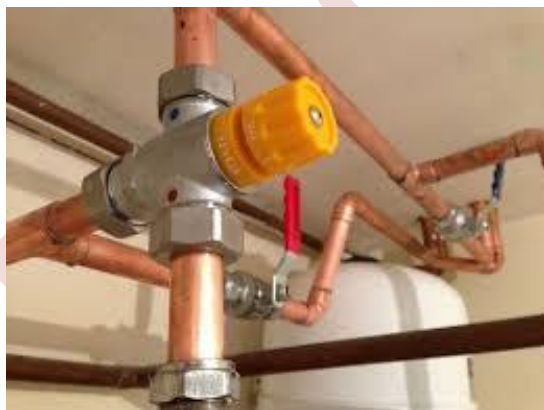
[Photo 5](#)

Thermostatic Valves		<i>All Rooms</i>	Passed	3.10
Radiator valve				
Actions * None	Compliances - Good head distance Non Compliances - None		(Photo 5)

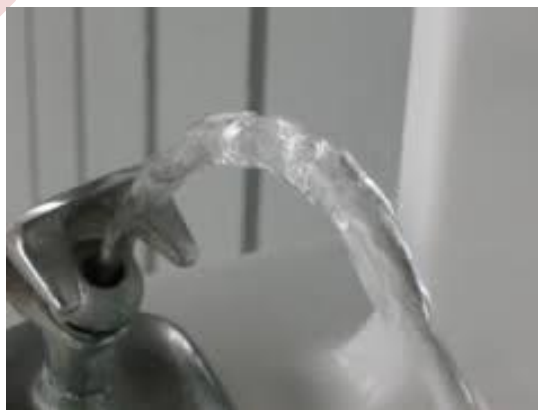
[Photo 6](#)

Water Fountains		<i>Office Areas</i>	Passed	3.11
Floor standing				
Actions * None	Compliances - Running temperature under 20c - No visible lime scale deposits - No visible contamination - No visible corrosion - Drain fitted Non Compliances - None		(Photo 6)

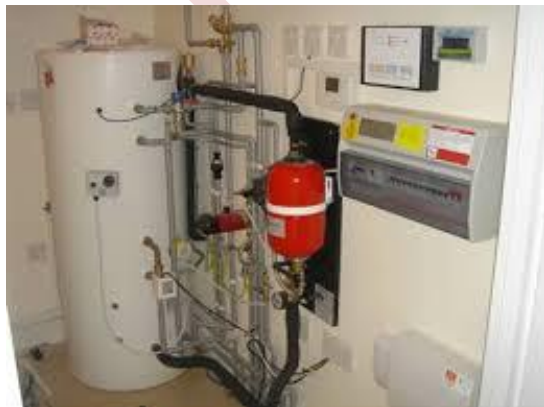
[Photo 7](#)

Hot Water Storage		<i>Boiler Room</i>	Borderline	3.7
Elson tank 110 litres				
Actions * Carry out full maintenance plan <i>Essential by 2017-10-10</i>	Compliances - No visible contamination - No visible corrosion Non Compliances - Visible contamination - Low flow water temperature		(Photo 7)

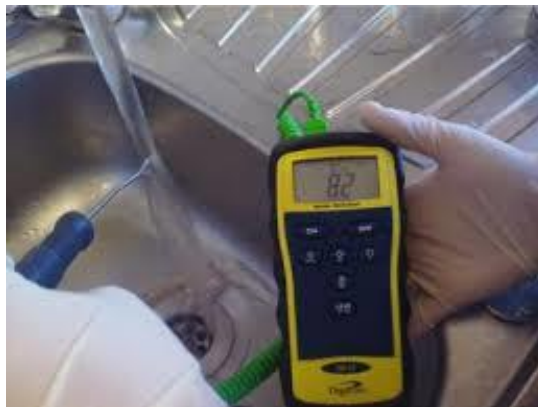
[Photo 8](#)

Cold Water Outlets		<i>Kitchen</i>	Passed	3.2
Mixer				
Actions * None	Compliances - Cold water temperature under 20c - No visible contamination - No visible lime scale deposits Non Compliances - None		(Photo 8)

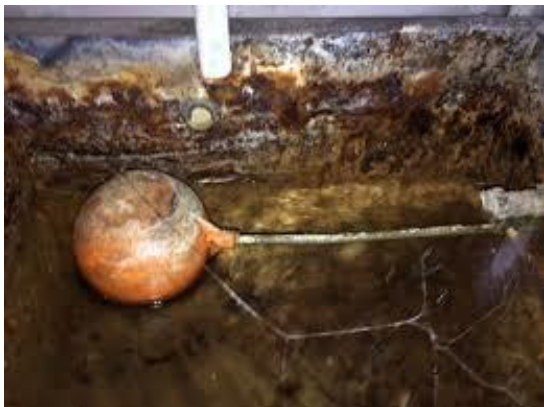
[Photo 9](#)

Cold Water Storage		<i>Loft</i>	Borderline	3.3
Non-insulated galvanized tank				
Actions * Empty tank and clean <i>Essential by 2017-10-10</i>	Compliances - Tight fitted lid Non Compliances - Visible corrosion		(Photo 9)

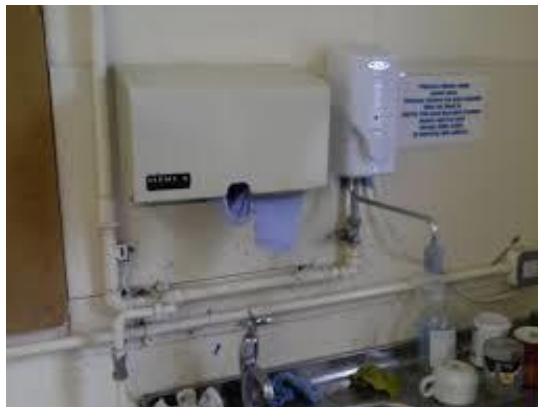
[Photo 10](#)

Point-of-use Water Heaters		<i>Ladies Toilet</i>	Passed	3.8
Electric				
Actions * None	Compliances - No visible corrosion - Used regularly Non Compliances - None		(Photo 10)

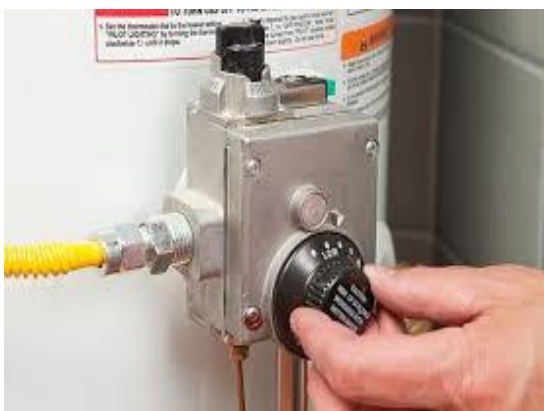
[Photo 11](#)

Water Heaters		<i>Gents Toilet</i>	Failed	3.12
Point of use				
Actions * Carry out full maintenance <i>Urgent by 2017-11-03</i>	Compliances - None Non Compliances - Visible lime scale deposits - Visible corrosion	(Photo 11)

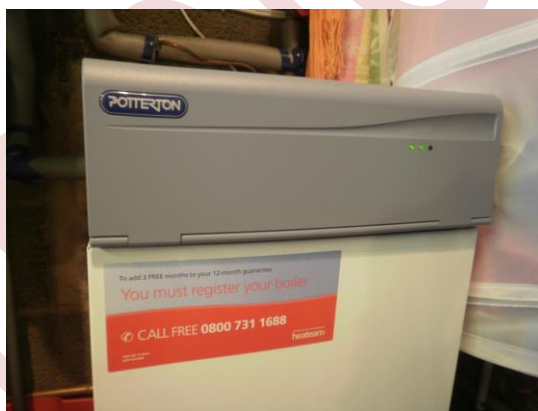
[Photo 12](#)

Boiler		<i>Boiler Room</i>	Borderline	3.1
Combination				
Actions * Ensure boiler temperature is 60c <i>Urgent by 2017-11-03</i>	Compliances - None Non Compliances - Boiler temperature set at below 60C		(Photo 12)

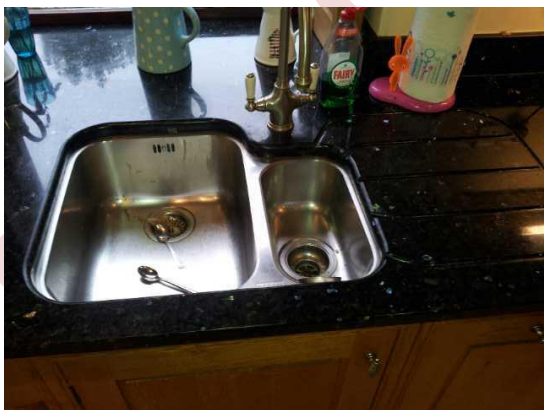
[Photo 13](#)

Water Supply		<i>Staff Room</i>	Passed	3.13
Mains with alkathene piping				
Actions * None	Compliances - No visible lime scale deposits - No visible contamination - No visible corrosion - Water softener installed - Backflow prevention in place - Pipework insulated Non Compliances - None	(Photo 13)
